# **PRESERVATION ASSESSMENT OF THE ELM STREET CEMETERY, BRAINTREE, MASSACHUSETTS**

**Chicora Research Contribution 529**

Prepared By:  
Michael Trinkley, Ph.D.  
Debi Hacker  
and  
Nicole Southerland

September 2010

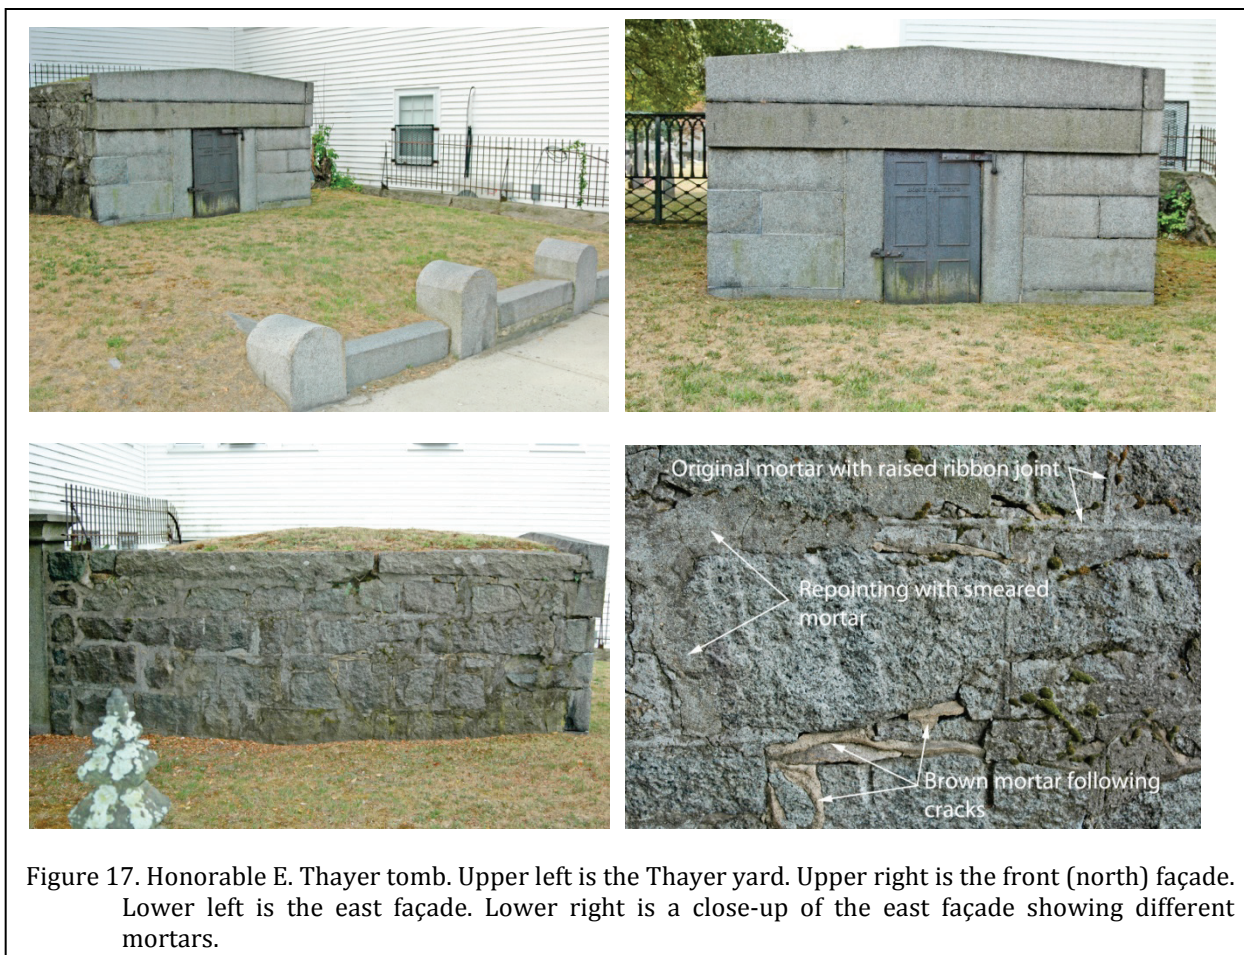
The side and rear walls consist of semi-dressed broken ashlar granite, set with a light gray mortar. The mortar joints exhibit a raised ribbon joint. At least one episode of repointing is evident, using a dark gray, hard mortar. Much of this work is poor, with the mortar smeared across the joints. Subsequently there was another repair episode, with a light brown mortar used to infill cracks. The top of the tomb is grassed and appears stable, although the interior of the tomb was not inspected.

The iron door is fabricated to resemble an eight-panel door with hinges on the right. A

lockable hasp is riveted to the left side of the door. The upper right hinge strap has separated from the door. The door is  $\frac{1}{2}$ " thick and  $2'2\frac{3}{4}$ " in width.

This tomb requires repointing. The sides and rear should use a 1:2.5 mix of NHL 5 and sand to match the original mortar in texture and color. Joints should be finished to match the existing raised ribbon joint. Hard, smeared mortars should be removed. The front of the tomb should have mortar removed and the joints pointed with lead to match the original work.

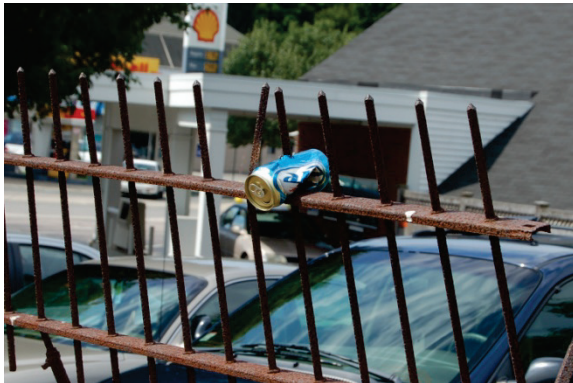
discarded in the cemetery from a second story bathroom window overlooking the cemetery on its western side. The Highways and Grounds Division should contact the owner of this structure and inform them of the problem, seeking assistance in preventing this littering. Absent cooperation the matter should be turned over to law enforcement in an effort to prevent the problem from continuing. Of course the cigarette butts must be collected by Highways and Grounds.

Figure 40. Trash at the Elm Street Cemetery.

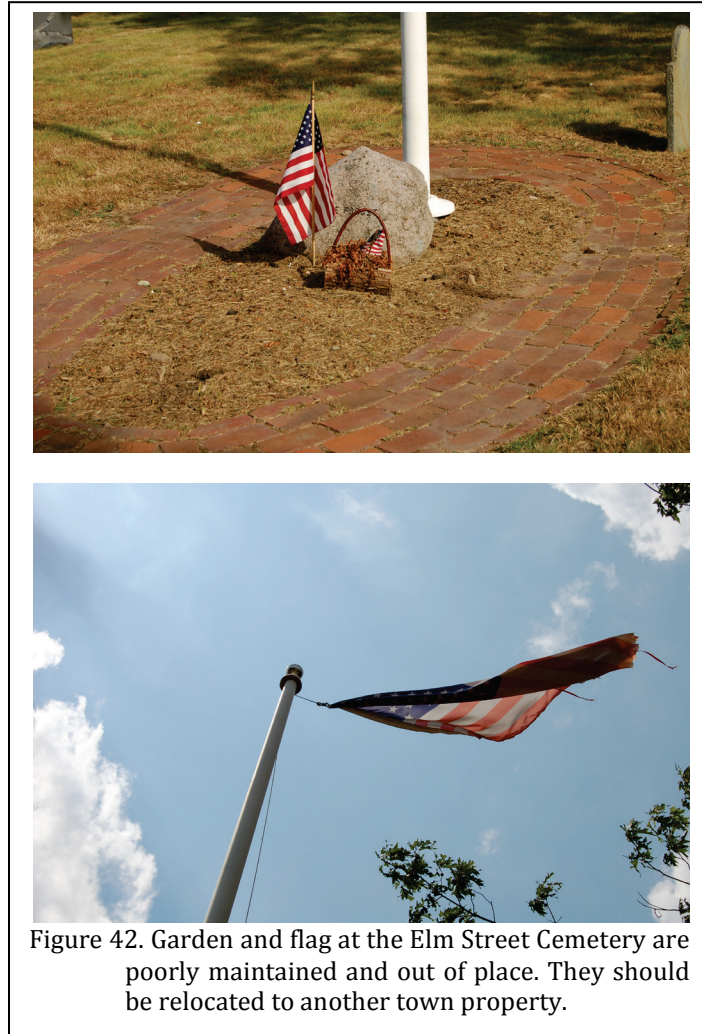
At some point a small oval garden and flagpole were erected in the cemetery. These features are out of place and detract from the historic significance of the cemetery. In addition, they are not being adequately maintained. The garden is weedy and the condition of the flag is

disgraceful.

The flag pole and garden should be removed from the Elm Street Cemetery. It might be relocated, if desired, to the currently active portion of the Braintree cemetery on Plain Street.

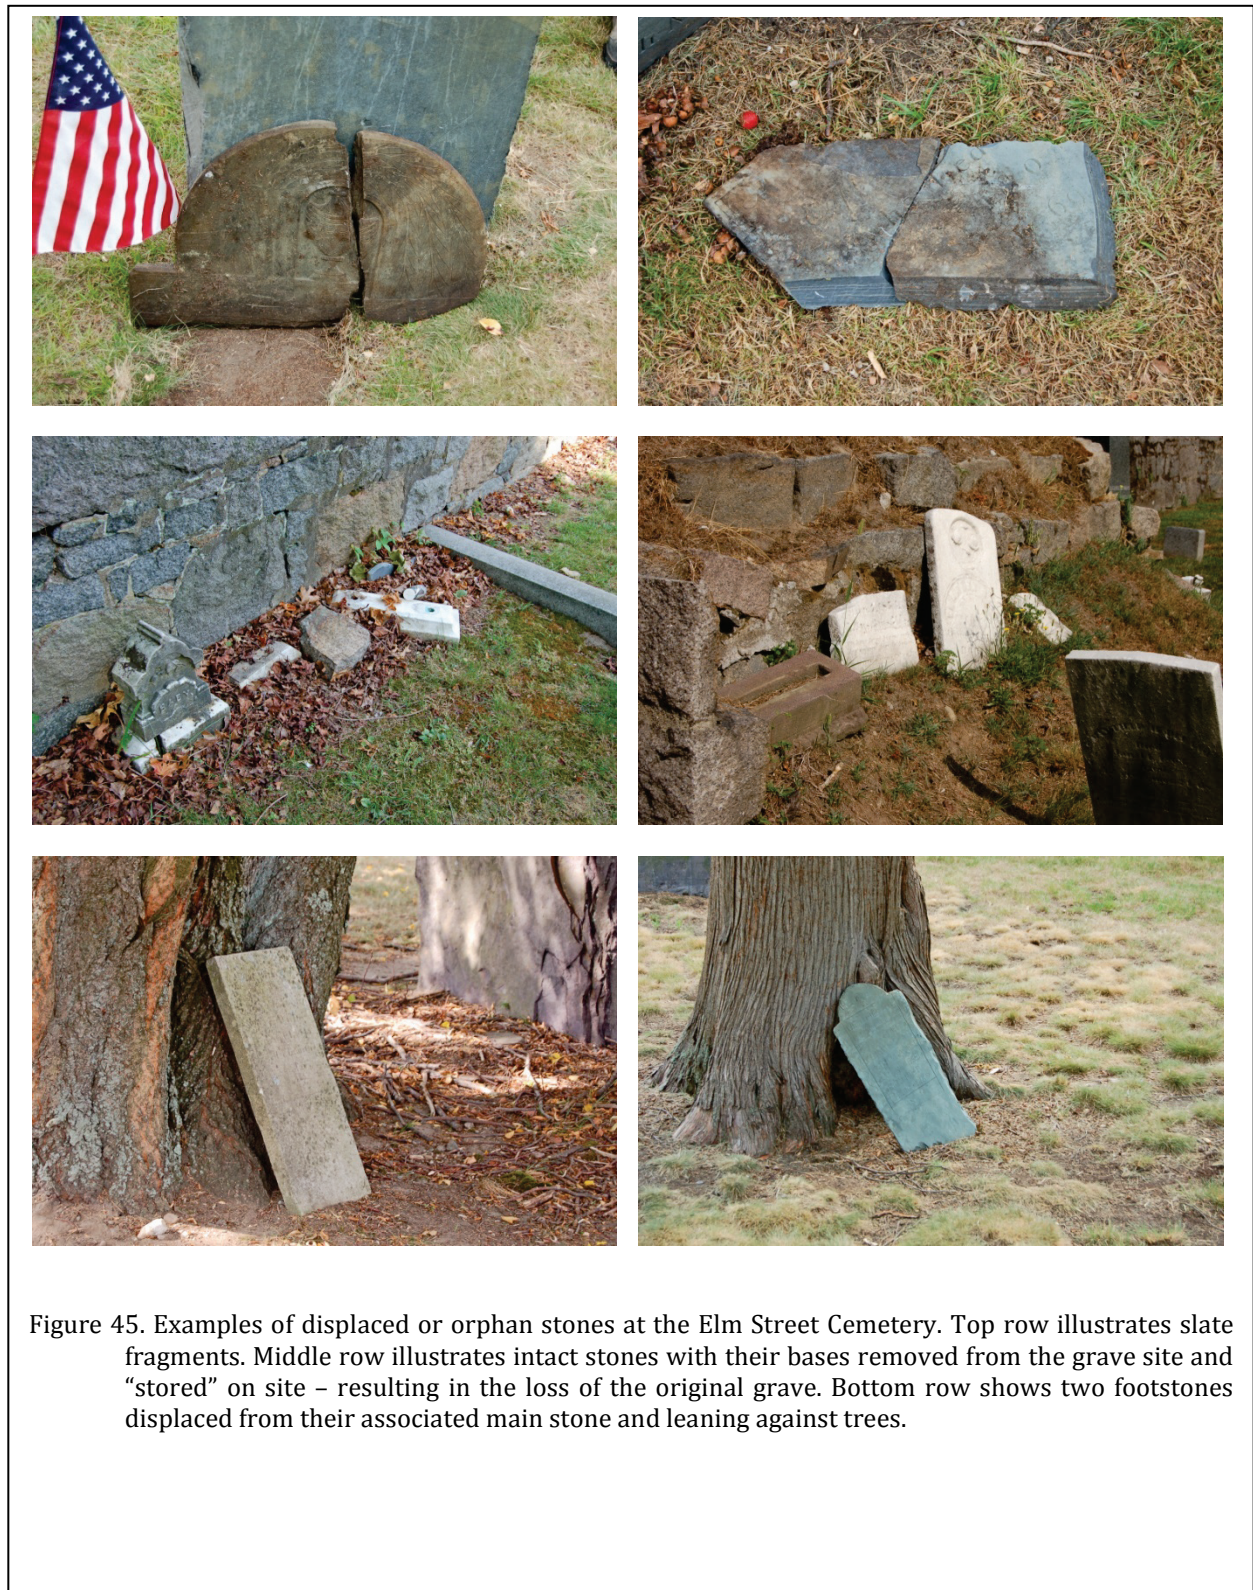
It is important to avoid inappropriate resetting methods. For example, we observed one tilted stone that had been “leveled” using a bit of tree branch. This will eventually decay, causing the stone to again fall, perhaps causing additional damage. It is also important to fully remove all old setting material, such as the Portland cement that had been used initially to set this stone (Figure 44).

While resetting can be done by a conservator, it is a task that volunteers can readily perform. The exception are larger stones that require drilling and pinning for stability.

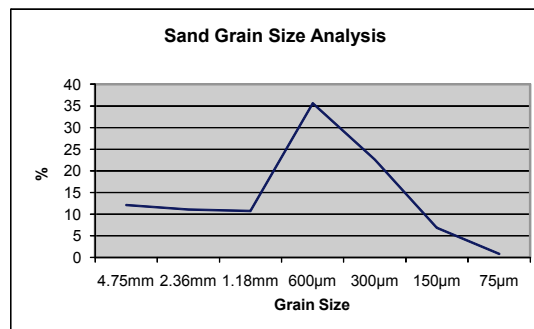
wt./% finer than	wt (gm)	%
4.75mm	0.00	0
2.36mm	0.44	12.1547
1.18mm	0.40	11.04972
600µm	0.39	10.77348
300µm	1.29	35.63536
150µm	0.82	22.65193
75µm	0.25	6.906077
53µm	0.03	0.828729
38µm	0.00	0
Total sand weight	<u>3.62</u>

**Munsell Color(s) of Sand:** light brownish gray (10YR6/2)

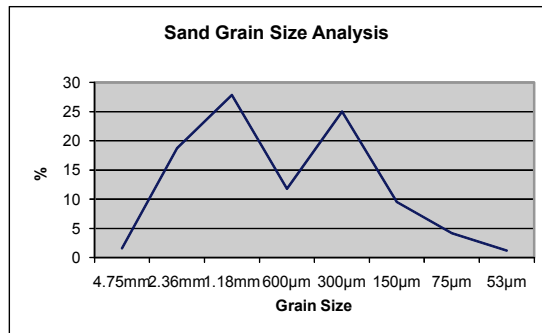
Gray (2.5YR5/1) with the appearance of a Portland cement. Moderate amounts of inclusions with few large items (largest was about 7.25 mm in diameter). Semi-rough texture with some large inclusions sitting on the surface. Easily broken, but not friable.

wt (gm)		%	
	wt (gm)	%	wt (gm)	%
wt. % finer than				
4.75mm	0.11	1.639344		
2.36mm	1.26	18.77794		
1.18mm	1.87	27.86885		
600µm	0.79	11.77347		
300µm	1.68	25.03726		
150µm	0.64	9.538003		
75µm	0.28	4.172876		
53µm	0.08	1.19225		
38µm	0.00	0		
Total sand weight	6.71

**Munsell Color(s) of Sand:** gray (2.5YR5/1)

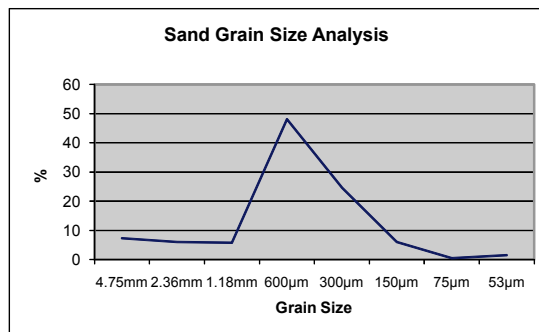
wt (gm)	%
wt. % finer than		
4.75mm	0.00	0
2.36mm	0.29	7.304786
1.18mm	0.24	6.04534
600µm	0.23	5.793451
300µm	1.91	48.11083
150µm	0.98	24.68514
75µm	0.24	6.04534
53µm	0.02	0.503778
38µm	0.06	1.511335
Total sand weight	3.97

**Munsell Color(s) of Sand:** pale brown (10YR6/3)

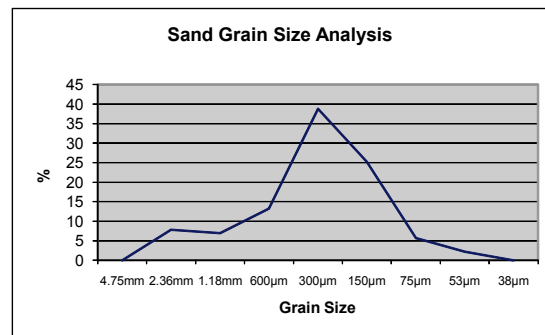
**Visual Description of sample (color, texture, hardness, inclusions, etc.):**  
 Very pale brown (10YR8/2); easily broken, very friable. Few visible inclusions, those present are very small. Slightly rough texture

<b>Microscopic Examination:</b> Subrounded to angular; quartzite, unknown metavolcanic, quartz.	wt. % finer than	4.75mm	<u>0.00</u>	<u>0</u>
		2.36mm	0.36	7.843137
		1.18mm	0.32	6.971678
		600µm	0.61	13.28976
		300µm	1.78	38.77996
		150µm	1.16	25.27233
		75µm	0.26	5.664488
		53µm	0.10	2.178649
		38µm	<u>0.00</u>	<u>0</u>
		Total sand weight		<u>4.59</u>

**Munsell Color(s) of Sand:** very pale brown (10YR8/2)
